Manhole Inspection Summary

Manhole # S25M__021MH

Location Address: **1009 S.CAREY ST.**

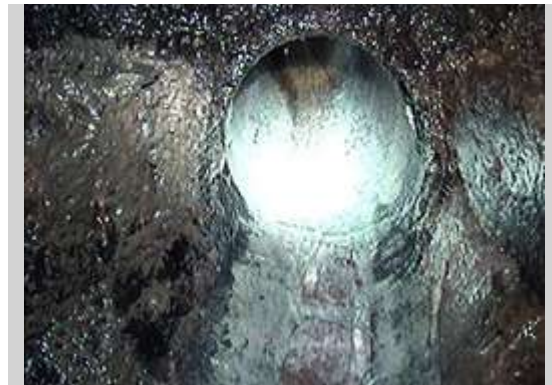
Drop In @ 3 O'Clock

Drop: **Inside** Rod and Bar
Angled: **Yes** Reading: **14.84** (ft.)
Inv Depth: **15.84** (ft.)
Drop Condition: **Open**
